ENVIRONMENTAL RISK ASSESSMENT SURVEY:
BRIGHTON LANDFILL
BRIGHTON, ILLINOIS

Job No. 916.4

March 21, 1985

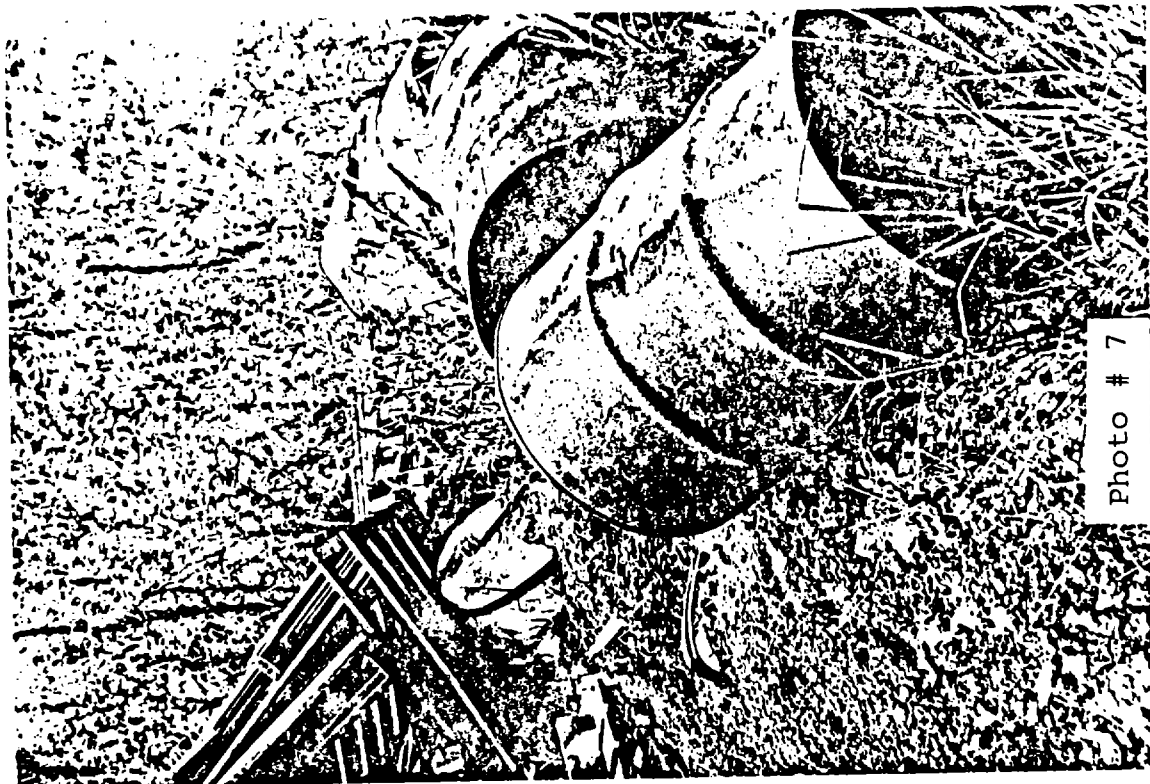
Photo # 7

The background sample of this branch (S.C. 877, pH 8.49) was considered important in that it was previously identified that considerable dumping of industrial residues has occurred along the Western bank upstream of the convergence with branch No. 4 (please refer to photos #5, #6, and #7).
